JACKSON TOWNSHIP

T 33 N, R 3 W J17

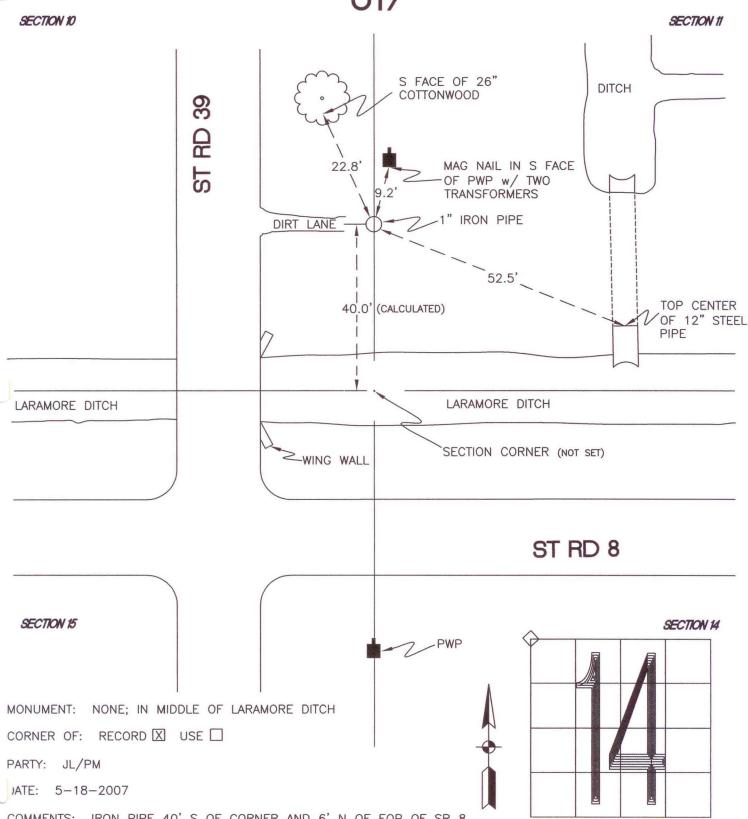
COMMENTS: IRON PIPE 40'S OF CORNER AND 6'N OF EOP OF SR 8

CORNER LOCATION IN THE SECTION USED AS A REFERENCE IN 1989 WAS PROBABLY DESTROYED BY INSTALLATION OF GUARD RAIL. UNABLE TO RESET: NO + IN SE WING WALL; NOT KNOWN WHICH PWP TO THE S OR WHICH MAPLE TO THE E ARE THE CORRECT REFERENCES TO THE IRON PIPE. STATE HIGHWAY DEPARTMENT HAS NO INFORMATION AFTER 1989.
