NORTH $\frac{1}{4}$ COR. SEC. 2
 (ACTUALLY S. $\frac{1}{4}$ COR. SEC. 35 T34N)
 - TIFIN SET NO CLOSING $\frac{1}{4}$ COR.

A-19c

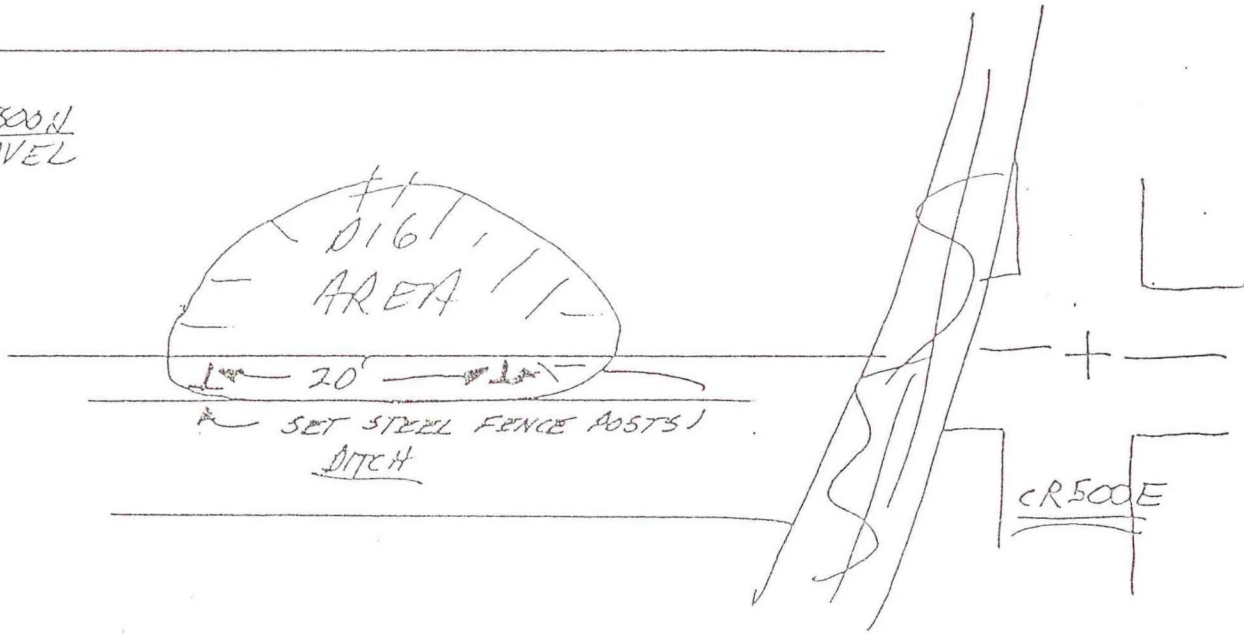
1. TUES 19 JUNE '90 DLA RLS 0537, P. MAYER ϕ .
WHEELED DIST. = 5227' FOR THE MILE. @ 2614 PAINTED SOUTH BERM. DITCH ALONG SOUTH EDGE OF ROAD FORCES ROADWAY NORTH SO THAT SOUTH BERM ALIGNS WITH CORNERS $\frac{1}{4}$ MILE EAST & WEST.
2. WED. 20 JUNE '90 DUG 18' X 20' X 4' DEEP HOLE ALONG BERM & SOUTH EDGE OF GRAVEL ROAD. FOUND NO POST, NO PIT, NO STONE; MONUMENT PROBABLY DESTROYED DURING DITCH CONSTRUCTION; DITCH & ROADWAY SHARE R/W.
3. THUR 21 JUNE '90 SET STEEL FENCE POSTS @ 20' APART NEAR SE & SW COR. OF HOLE ALONG DITCH BANK TOP.

NO MONUMENT
